Kagel Environmental, LLC

April 30, 2014

This is in regard to the field inspection and environmental site assessment that we, Kagel Environmental, LLC (KE), performed for you on the property of Andrew Johnson on Saturday, April 5, 2014. The subject project site is located within an approximate 8-acre farm parcel of land owned by Mr. Johnson, and is described as being within Section 30, Township 15 North, Range 115 West, Uinta County, near Fort Bridger, Wyoming. The purpose of this site assessment was to provide you (Frank Law Office, P.C.), with KE's professional opinion regarding the general identification and location of the extent of any federally regulated waters of the U.S., including wetlands, especially as regards the potential violation of the Clean Water Act as alleged in 2013 by the U.S. Army Corps of Engineers (COE), and the Environmental Protection Agency (EPA). As a former COE senior regulatory project manager and enforcement officer, the methodology KE used to identify the existence of regulated areas and/or impacted aquatic resources, etc., was that approved by the U.S. Army Corps of Engineers and Environmental Protection Agency, including adherence to the official

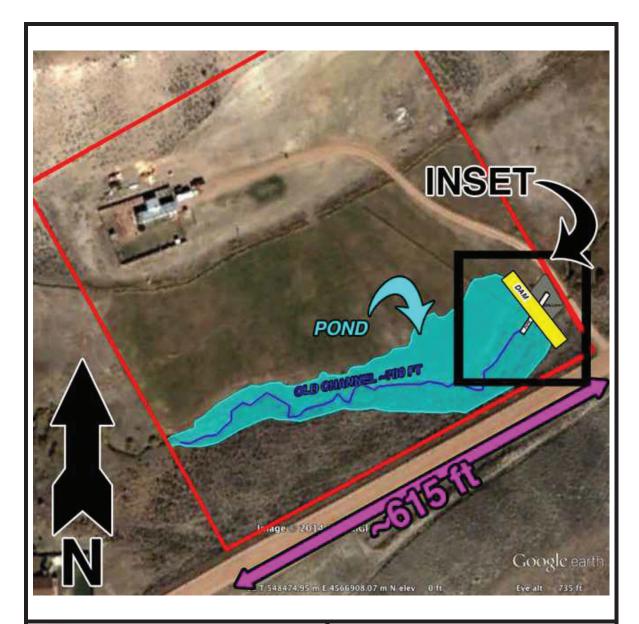
FIGURE 1. OVERVIEW OF THE JOHNSON STOCK WATERING POND.

The original channel, as traced on historical aerial photographs, is represented by the blue line and meandered for approximately 700 feet on the Johnson property. An approximate representation of the pond is highlighted in aqua. The dam construction is shown within a black frame, and is blown up in the next figure.

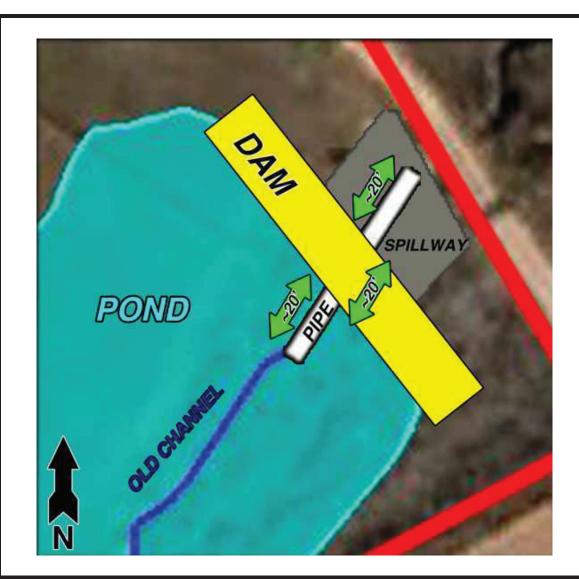
FIGURE 2. DAM CONSTRUCTION ON THE JOHNSON PROPERTY.

The dam is represented by the yellow triangle. The pipe through the dam is shown, and approximate lengths in the channel are indicated.

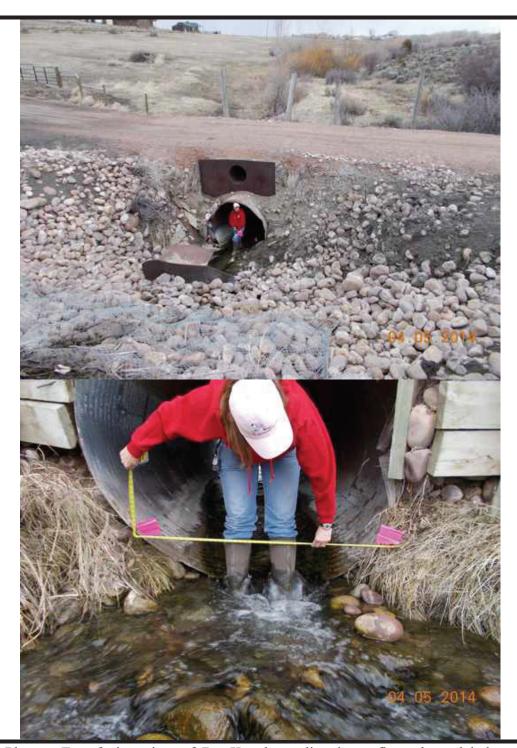
Top Photo: East facing view of Dr. Kagel standing in outflow channel below dam. Bottom Photo: Close-up western view of Dr. Kagel measuring OHWM width.

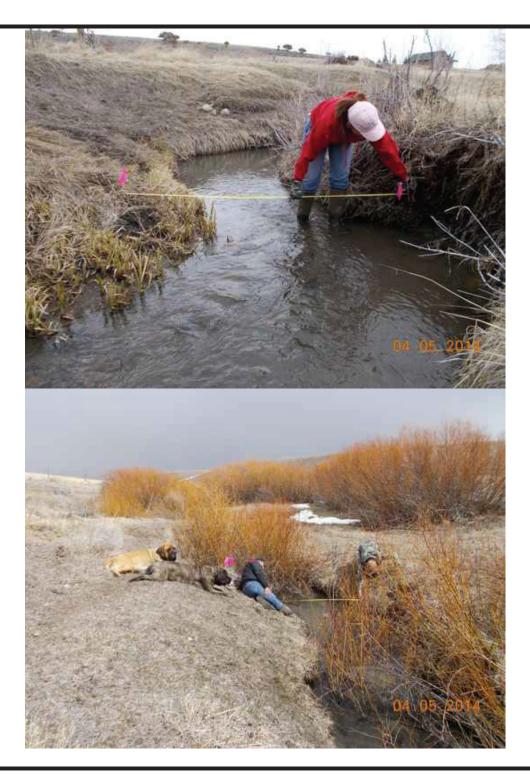
Top Photo: East view of downstream channel width (84") at the OHWM. Bottom Photo: Downstream (east) view of the channel above the pond.

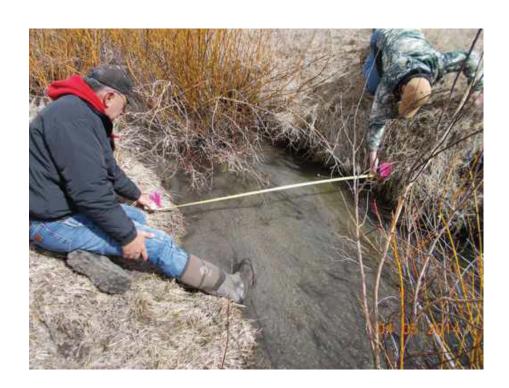
Close-up view of measuring width and depth of channel upstream of Johnson pond.

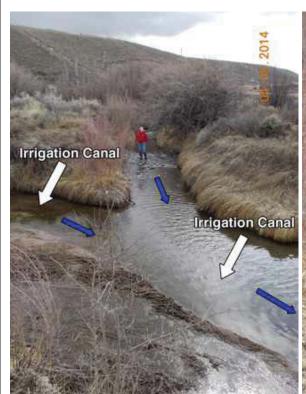
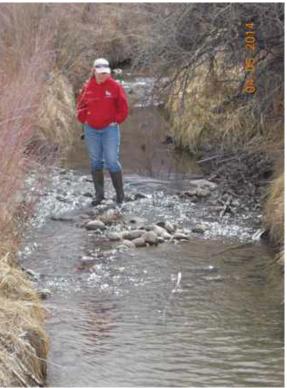
Left Photo: Upstream (western) view of Dr. Kagel standing in Six-Mile Creek near its terminus in a man-made irrigation canal. Blue arrows indicate water flow direction. Right Photo: Close up of same view of Six-Mile Creek at the confluence with the irrigation canal.

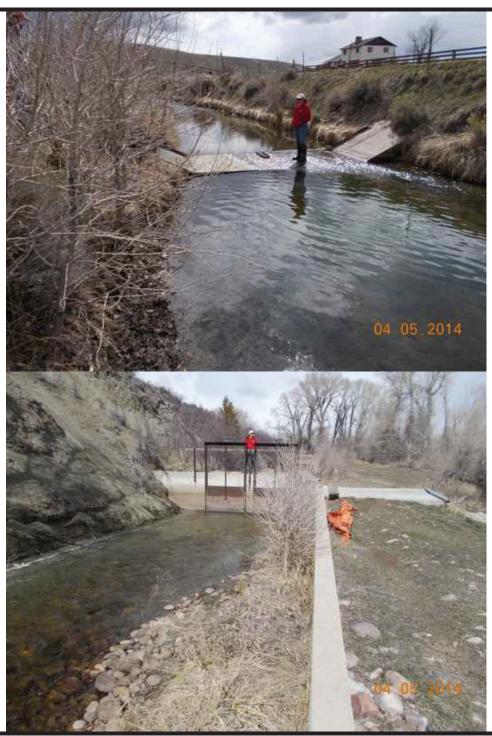
Top Photo: Downstream view of irrigation canal that receives 100% of Six-Mile Creek flow. Bottom Photo: Upstream view of irrigation canal with Dr. Kagel standing above water control structure.
